# BETTER PREPARED

It has been another safer six months to fly. Declining global accident rates, however, raise the prospect of complacency, so safety bodies are encouraging the industry to learn more from incidents where no damage occurred and to be ready to deal with the unexpected

DAVID LEARMOUNT LONDON

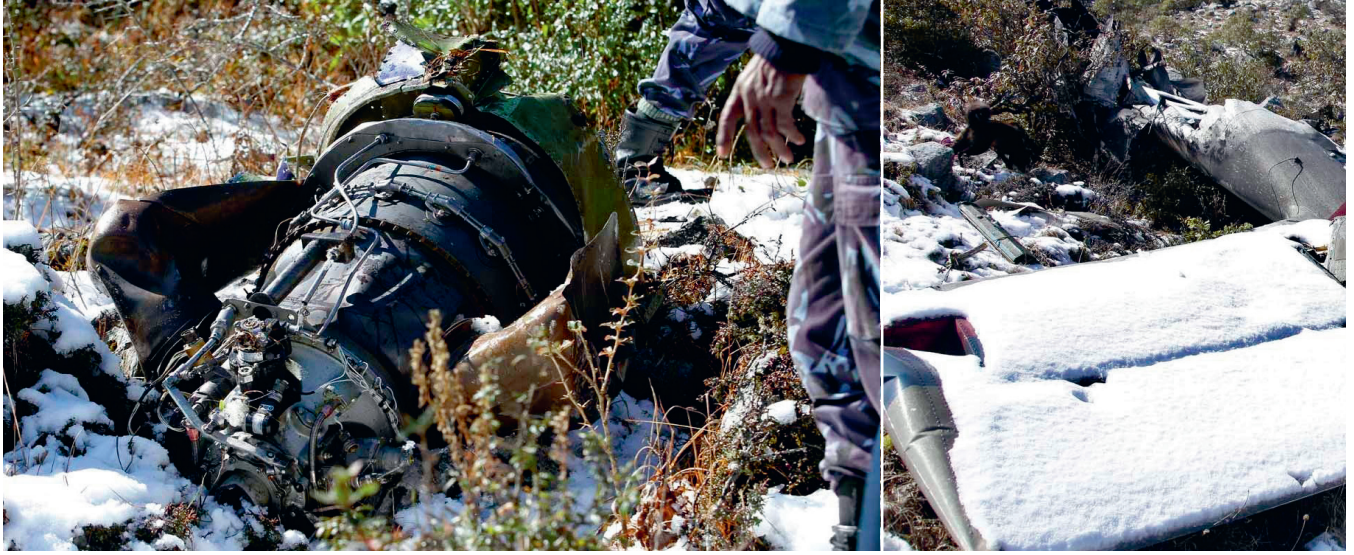
The 30 June fatal crash of a Nepal Airlines Twin Otter was the only one involving a commercial passenger aircraft in the first six months

The largest passenger aircraft involved in a fatal accident this year to 30 June was a 19-seat Nepal Airlines de Havilland Canada Twin Otter. It was the only commercial transport passenger aircraft fatal accident. The others all involved non-passenger operations (see accident list).
